Manhole Inspection Summary

Manhole # S21I__033MH

Location Address: **1939 HOLLINS-FREDICK**

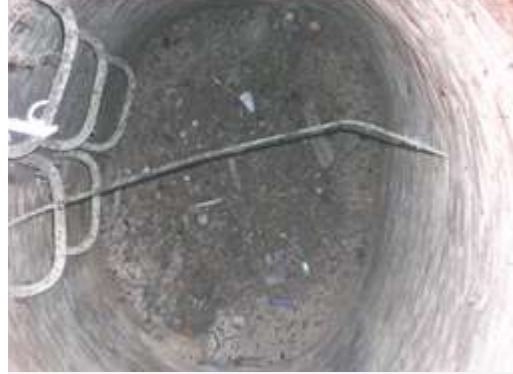
Top View

DEBRIS IN CHANNEL

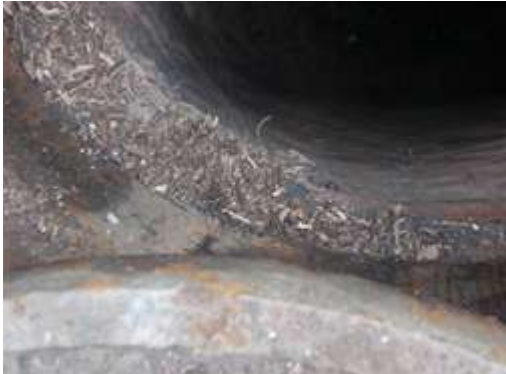
Defect 2

Frame Offset: **4** (in.) Condition: ☐ Sound ☒ **Cracked** ☐ Leaks

FRAME OFFSET

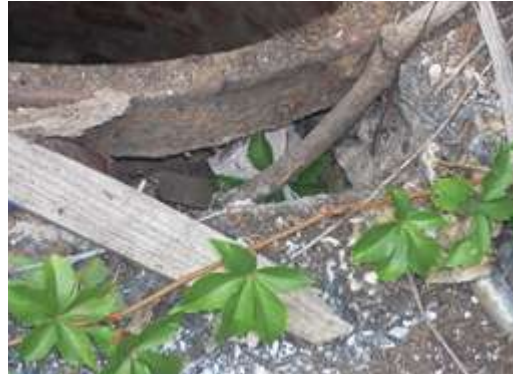
Defect 1

CRACK/DETERIORATION OF
CONCRETE AROUND FRAME

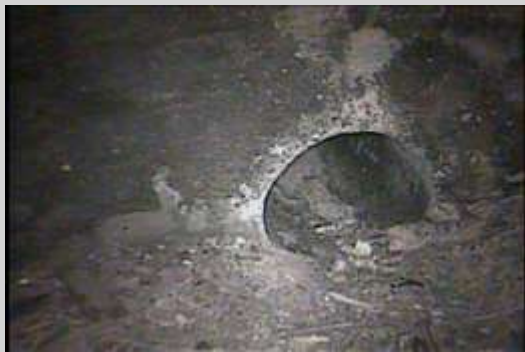
12 O'Clock Outflow

FRAME OFFSET

Pipe Height: **7.2** (in.) Rod and Bar (Angled)
Pipe Material: **Clay** ☐ Pipe Lined
Invert Depth: **11.79** (ft.) Flow Characteristics: **Slow**
Deposits: ☐ None ☐ Mud ☒ **Sludge** ☐ Debris ☐ Grease
Silt Depth: **2** (in.) Deposits Extent: **Light**
Infiltration: **None** Pipe Seal Cond: **Sound**

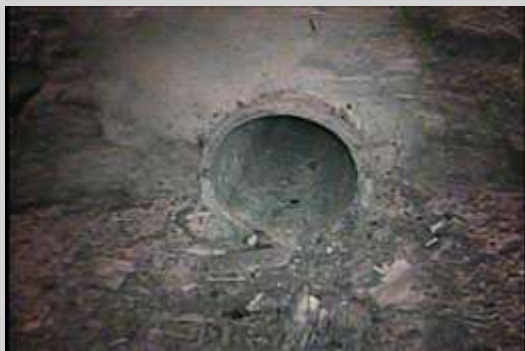
6 O'Clock Inflow

FRAME OFFSET

Pipe Height: **6** (in.) Rod and Bar (Angled)
Pipe Material: **Clay** ☐ Pipe Lined
Invert Depth: **11.39** (ft.) Flow Characteristics: **None**
Deposits: ☒ None ☐ Mud ☐ Sludge ☐ Debris ☐ Grease
Silt Depth: (in.) Deposits Extent:
Infiltration: **None** Pipe Seal Cond: **Sound**
